Gribdale Gate, the pronounced col in the west-facing escarpment of the moors, just three kilometres from Great Ayton, is well-known to Aytonians and visitors alike. This is a favourite starting point for walkers making for Roseberry Topping or Capt. Cook's Monument on Easby Moor. It was in this area that an alum works was active, albeit briefly, in the eighteenth century (Figure 1)

Ayton Banks alum works is one in a line of activity extending from Selby Hagg to Thimbleby near Osmotherley. The site is protected as an Ancient Monument (RSM 31343, National Monuments Record No. NZ 51 SE 60). It lies in private scrubland with open access, 400m south of Gribdale Gate car park.

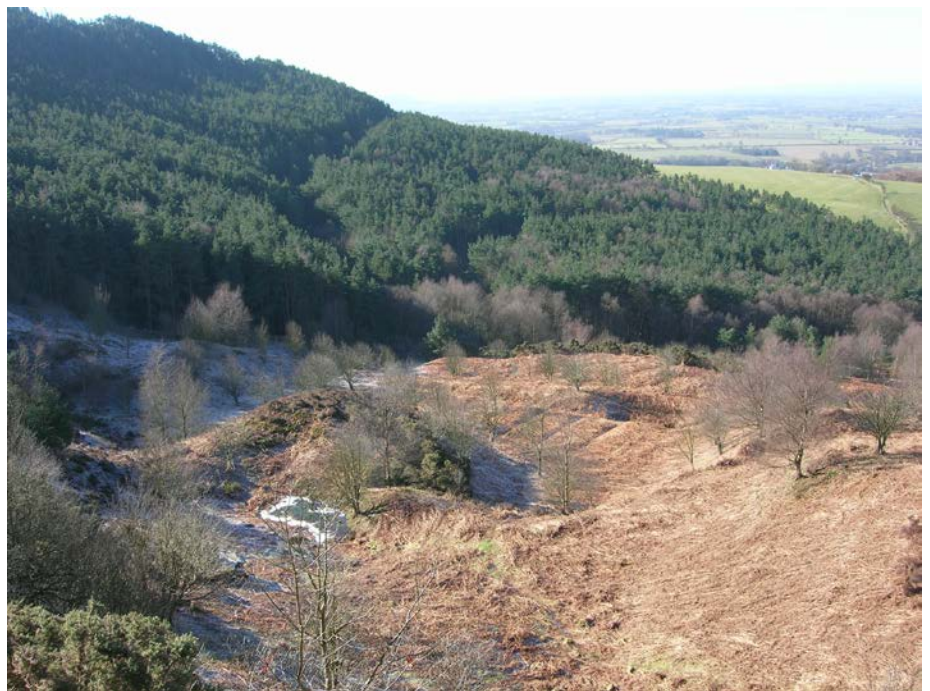
**Figure 2 Remains of alum works from Cockshaw sandstone quarry, showing reservoir, clamp, leaching pits, cisterns and spoil heap.**

The best viewpoint can be reached by climbing south from the col along a well trodden path to Cockshaw sandstone quarry which lies immediately above the alum works. It seems very likely that this quarry provided stone for the various structures used in the production of the alum crystals. The layout of the small works can be seen from the edge of the quarry looking west (Figure 2). A copy of an engraving of 1814 (See Fig.2) illustrates well the early phases of activity.

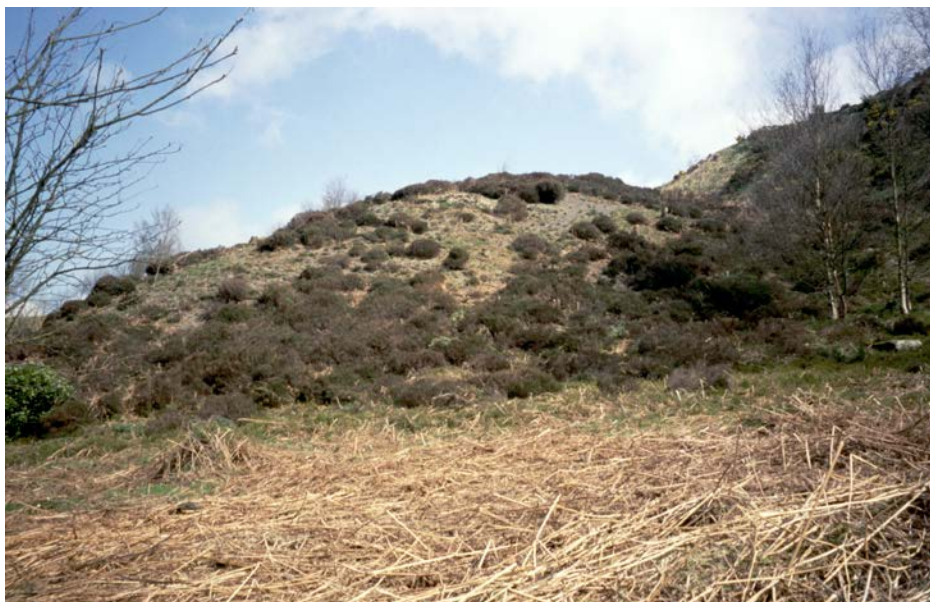
**Figure 5 Clamp, fired but not opened**

a conical clamp.(Figure 5) This mound can be seen from the viewpoint. Closer examination reveals that the shale is protected by a thin veneer of clay. In places the shale can be seen through the clay and its colour indicates that it has been burnt. Documentary evidence indicates that this clay covering was intended to be a temporary measure, giving protection from the weather, the assumption being that the market would pick up and the calcined shale would be available for processing later.

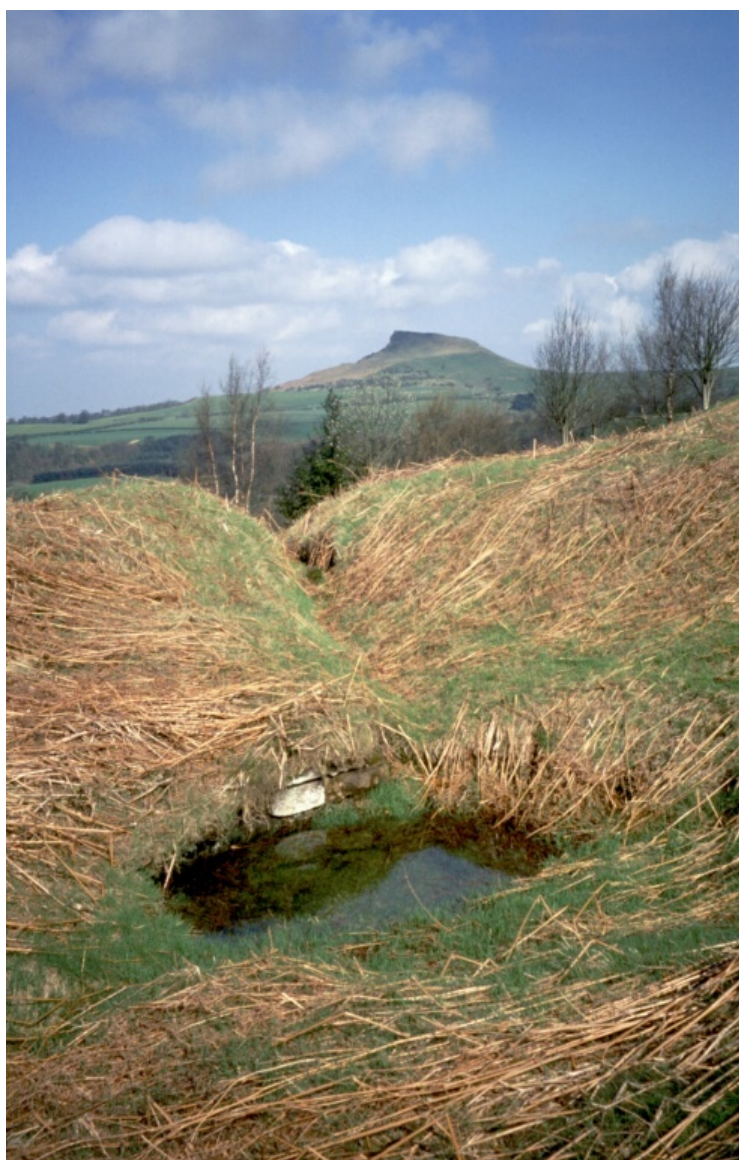
**Fig.6 Remains of one of the liquor cisterns**

permitting!). Water from the small reservoir was used in this complicated and skilled process of leaching, in order to dissolve out the aluminium sulphate. When the correct concentration was reached. the liquor was run along channels to two circular cisterns which can be seen with their corbelled, dressed sandstone walls.(Figure 6) The dimensions of the steeping pits and cisterns are very similar to those exposed by excavation some time ago at Carlton alum works.

After being allowed to settle in the cisterns, protected from the elements by a wooden lid, the liquor was pumped into a channel to begin the journey of about 500metres to the boil house. Only the first 20metres of this channel can be seen today, as the land along its route has been disturbed by later jet and ironstone workings.
