Fig 1 All Saints Church Great Ayton from the south

The oldest building in Great Ayton is, by several hundred years, the Church of All Saints (Fig 1). This important Grade 1 Listed building is situated west of the present village centre, a short distance from the Low Green and crucially a few metres above the flood plain of the River Leven. It served as the Parish Church of Great Ayton from its construction in the twelfth century until Christ Church was built in 1876. Not surprisingly, this Norman building has seen many alterations and additions over the centuries. These changes in its fabric and furnishings reflect changes in the social and economic development of the village. Its demise as the Parish Church in Victorian times resulted from population growth linked to the development of various industries.

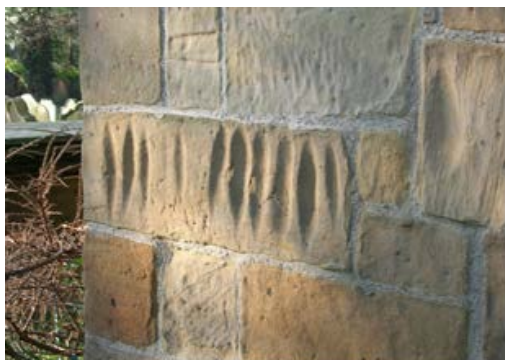
Fig 3 Exterior of chancel gable. Grooves probably made by archers sharpening arrow heads

The east end of the church has a decorated triple lancet window, installed in 1880, replacing earlier windows. At the south side of this gable, grooves can be seen incised in the stonework (Fig 3). These were probably cut by archers sharpening their arrowheads when involved in compulsory butts practice near the church. This activity was begun in the reign of Edward I. Ten metres directly east of that corner the Cook family grave is located. The family moved into Great Ayton in 1736 and would have worshipped at All Saints. Captain James Cook's mother and five siblings are buried here. The details are engraved on the front of the headstone, with recent explanations regarding the great navigator on the back of the stone:

Entering the church through the porch, the fine Norman doorway can be seen (Fig 9). It has a semicircular arch of three orders, the outer being carved with the typical chevron ornament. The arch is supported on twin columns. Sharpening grooves, seen in the exterior of the east wall of the chancel, are very common in the porch stonework.

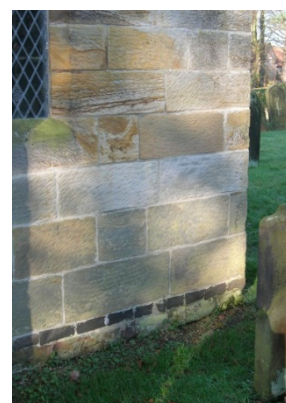
On the north side of the building the vestry can be seen with more recent stonework. (Fig 4). It was added to the chancel in 1849, complete with a fireplace, as the chimney indicates. At ground level whinstone foundations are evident. By this time the whinstone basaltic dyke, which outcrops nearby, was being worked to produce setts such as these.

Fig 4 Exterior of vestry

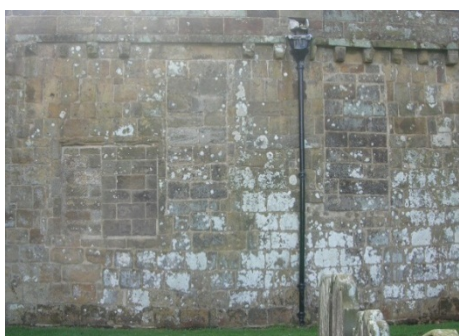
Fig 5 Exterior of north nave wall. Sealed window and doors

The North wall of the nave shows a complicated pattern of masonry, illustrating changes in the use of the building throughout its history (Fig 5). At the east end there is an almost square blocked-up window, which appears to have been sealed in

two phases. Careful examination of the lintel shows it was designed to have three lights. Its form suggests a fifteenth century date. To the right, at a much higher level, there are two large sealed apertures. The lintel of the first is so high that it has broken into the design of the corbel. Near the west

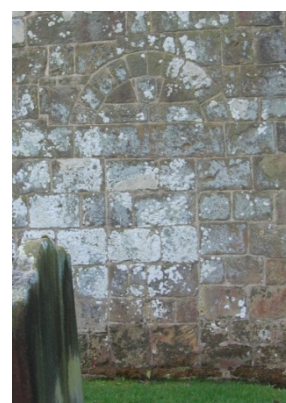
end of the north wall a carefully sealed arched doorway with horizontal lintel can be seen (Fig 6). For a better understanding of these blocked-up features it is necessary to examine them from the interior.

Fig 6 Exterior of north nave wall. Sealed Norman doorway

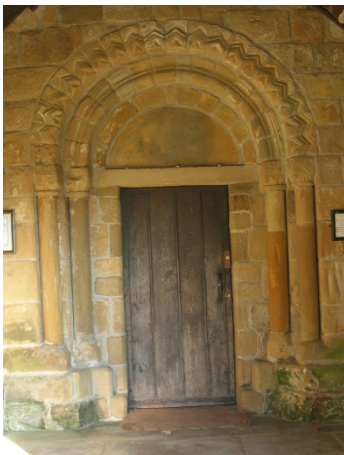
Fig 9 Norman doorway

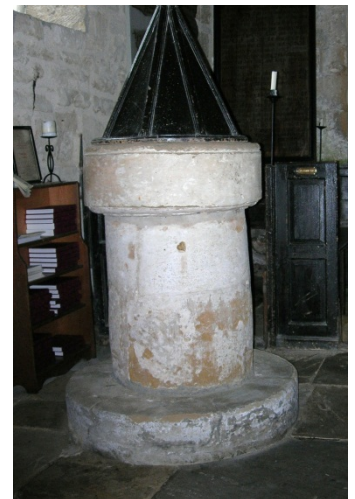
The font, at the back of the nave, is Norman (Fig 10). It has a conical wooden cover. The exposed masonry throughout the interior is much less regular than its counterpart on the exterior. Until the twentieth century it would have been plastered and either white or, in pre-Reformation times, bearing colourful murals. The early roof beams were exposed in 1933. Prior to that, the entire church was barrel-vaulted with a plaster ceiling. The present pews were installed in the mid 1700s. They replaced gated pews which were much higher.

Fig 10 Font, 12th century

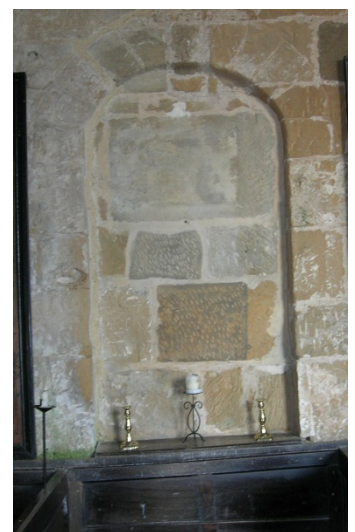
generally referred to as the Devil's Doorway. Its function is said by some to have been to let out the Devil if a child cried during baptism. Others, however, hold the belief that it would have been used for processional purposes.

The north wall carries the scars of 900 years of alterations (Fig 11). Near the west end of the wall the blocked-up Norman doorway with arch (Fig 12) is the same doorway seen on the exterior. It is

Fig 12 Devil's doorway

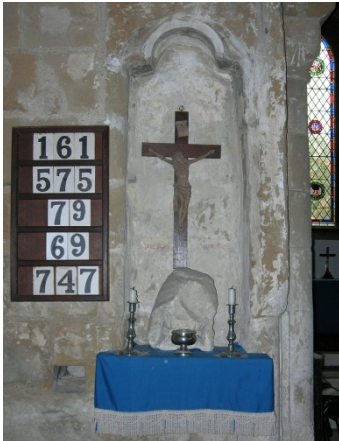
Written evidence suggests that in pre-Reformation days a small chapel or chantry dedicated to St Mary existed within All Saints. Its location remained a mystery however, until 1915 when major restoration work was undertaken. A sealed-up niche was discovered, plastered over, in the nave on the north side of

the chancel arch. This recess with its trefoil head has been reinstated. A will of 1540 explains that the niche held an image of Our Lady. The remains of such an image was found in the vicarage garden early in the twentieth century and has been placed in the niche (Fig 15). The blocked-up Tudor window at the extreme east of the north nave wall is adjacent to this chapel. It seems likely that this three light window illuminated the shrine. In the recess of this sealed window several sculptured stones of pre-Norman age are housed. There are two of particular note; a cross head of late tenth to early eleventh century (Fig 16) and a cross head in two pieces, also Anglian. These were discovered near the church and have been accepted as proof that the Anglo Saxon church mentioned in the Domesday Book stood on this site.

Fig 15 Pre- Reformation chapel niche, exposed

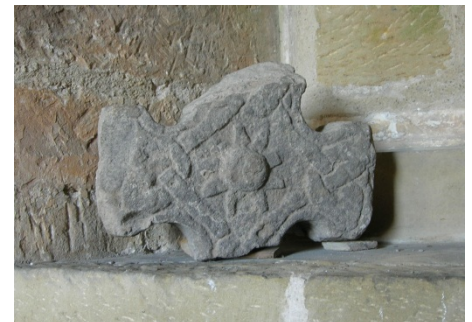
Fig 16 Pre Norman cross head

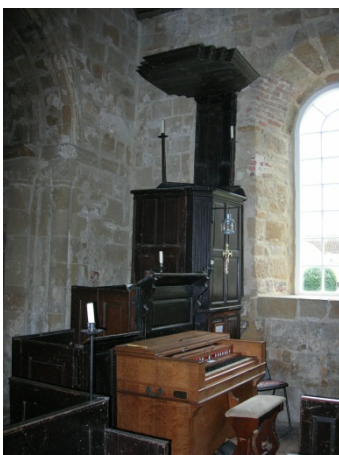
Fig 17 Three decker pulpit with sounding board

On the opposite side of the chancel arch stands a three-decker pulpit (Fig 17). This bold feature was added to the furniture in the mid 1700's, comprising, in ascending order, clerk's desk, reading desk and preaching platform. Overhead there is a sounding board. It is interesting to note that even when preaching from the top tier, the curate would be looking up to those in the private gallery!

The break with Rome in 1533/4 had a dramatic effect on the appearance of the interior of All Saints. For centuries there would have been an intricate coloured rood screen masking the lower area of the chancel arch and a loft or beam above this with paintings. Traces of the steps giving access to the loft can still be seen behind the pulpit.

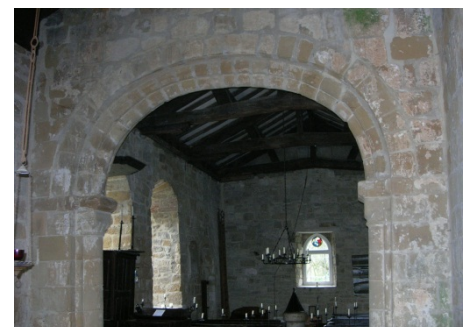
The Norman chancel arch is well seen from within the chancel looking west (Fig 18).

Fig 18 Chancel arch from the east

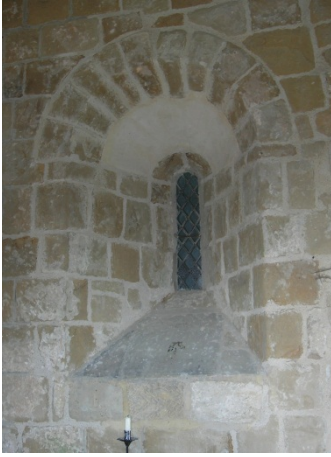
From this situation it is useful to compare the present truncated nave with the pre 1880 view, with the galleries and their access doors and vaulted ceiling. It is fortunate that in the chancel we find the only Norman window of All Saints (Fig 19). Because the vestry was built onto the side of the chancel,

Fig 19 Norman window, chancel

this window now simply links the two parts of the church. The great thickness of the wall is apparent. Repairs undertaken at various places recently show that the walls were built with two skins of cut stones and rubble was used to fill the space inside. The steeply sloping sill is cut from a gravestone bearing traces of its inscription. Initially, this would be the style of fenestration used throughout the church. Because of the minute apertures, very little daylight got into the building.
